SECTION 5

Existing Conditions

EXISTING CONDITIONS OVERALL SITE

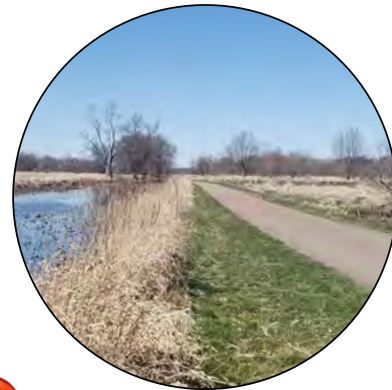
1 CHIPPEWA INLET TRAILHEAD - SOUTH

Existing shared-use trail to the north allows for connections to Buckeye Woods and Chippewa Inlet North Trail.

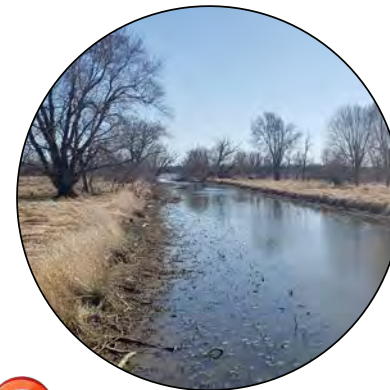
2 CHIPPEWA INLET

Surrounding agricultural lands result in high levels of contaminated runoff. The stream delta creates opportunity for restoration and enhancements of water before entering lake. Existing wetland restoration projects happening currently within this area.

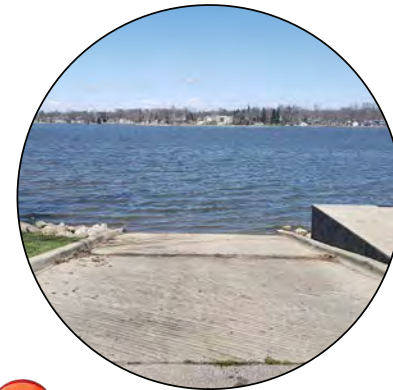
4 CHIPPEWA LAKE BOAT LAUNCH

Existing boat launch is functional but lacks facilities for a variety of other boat types (canoe, kayak, paddle board, etc.).

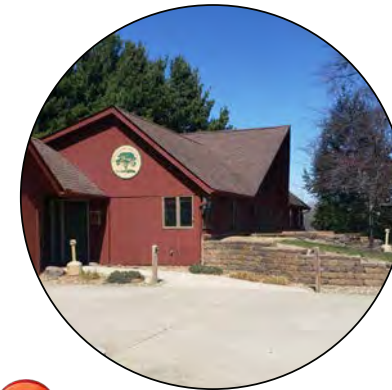
5 KRABILL LODGE

Existing park shelter, Krabill Lodge, on west side of lake offers a central facility for passive recreation.

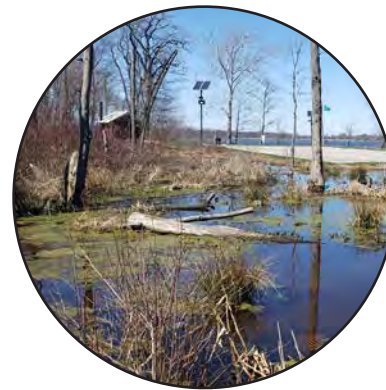
WETLANDS

Existing wetlands create environmental and aesthetic benefits to park experience. Potential challenges with unfiltered roadway runoff entering directly into wetland zones.

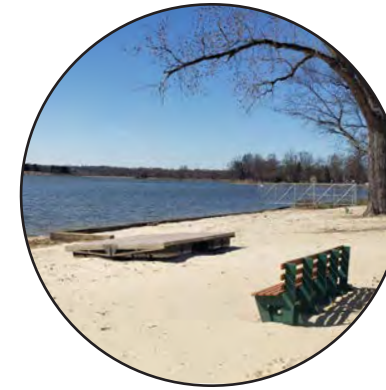
VILLAGE'S BEACH

Current beach access allows for vast lake views. Opportunities to remove hardened shoreline design, making pedestrian interaction with shoreline a more direct and natural experience.

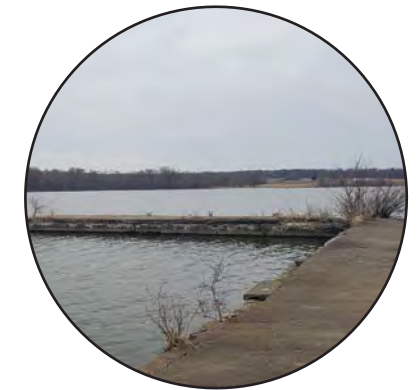
EXISTING PIER

Structural issues exist with pier, including crumbling concrete and plant roots contributing to deteriorating state. Opportunities for new pier would create a safer experience and an enhanced appearance at the water's edge.

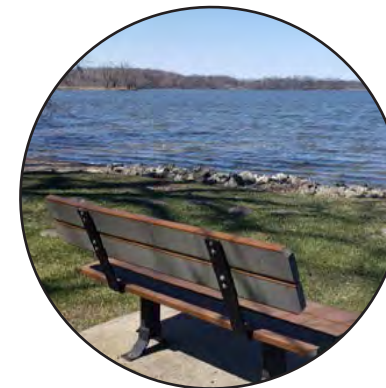
EXISTING SHORELINE

Existing amenities begin to capitalize on shoreline views. Potential for improving shoreline ecology and aesthetics.

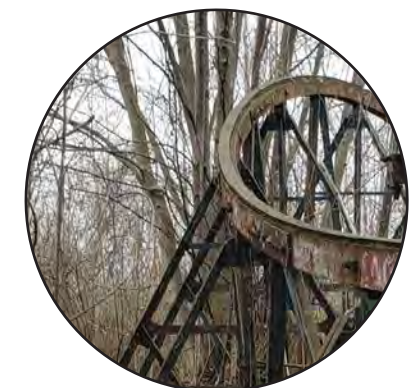
HISTORIC RELICS

Remnants of several amusement park rides create opportunities to highlight site history but present visitor safety challenges.
